Manhole Inspection Summary

Manhole # S47EE_009MH

Insp Date: **7/17/08 11:26 AM**

Location Address: **Collington**

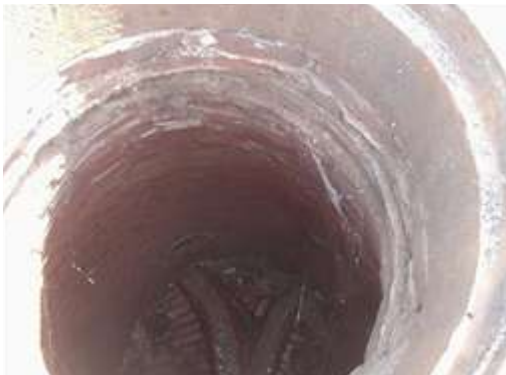
Defect 1

Infiltration

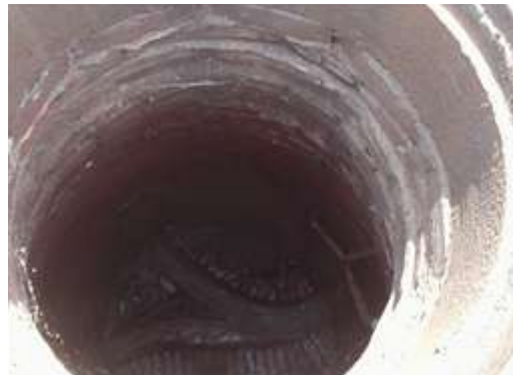
Defect 2

Frame leaks

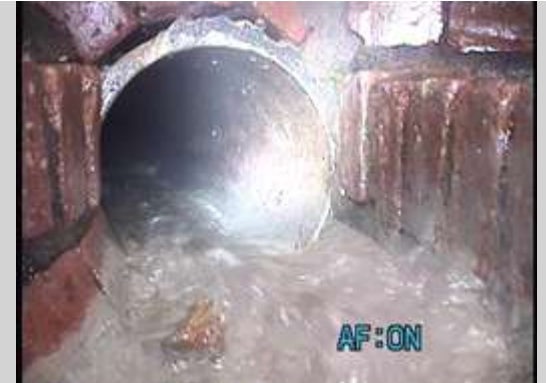
12 O'Clock Outflow

10 in. Circular Gravity Sewer
Pipe Out @ 12 O'Clock

Pipe Height: **10.8** (in.) Rod and Bar (Angled)
Pipe Material: **Clay** ☐ Pipe Lined
Invert Depth: **11.70** (ft.) Flow Characteristics: **Fast**
Deposits: ☒ None ☐ Mud ☐ Sludge ☐ Debris ☐ Grease
Silt Depth: (in.) Deposits Extent:
Infiltration: **None** Pipe Seal Cond: **Sound**

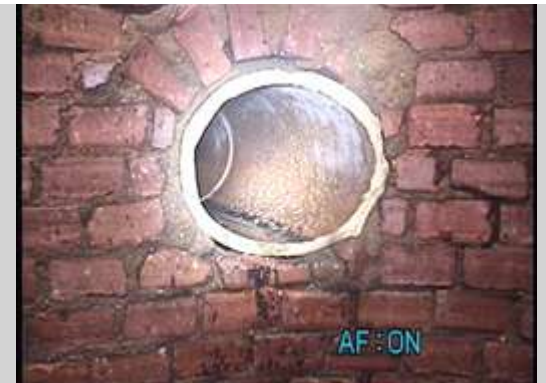
6 O'Clock Inflow

8 in. Circular Gravity Sewer
Pipe In @ 6 O'Clock

Pipe Height: **8.4** (in.) Rod and Bar (Angled)
Pipe Material: **Clay** ☐ Pipe Lined
Invert Depth: **9.55** (ft.) Flow Characteristics: **Fast**
Deposits: ☒ None ☐ Mud ☐ Sludge ☐ Debris ☐ Grease
Silt Depth: (in.) Deposits Extent:
Infiltration: **None** Pipe Seal Cond: **Sound**

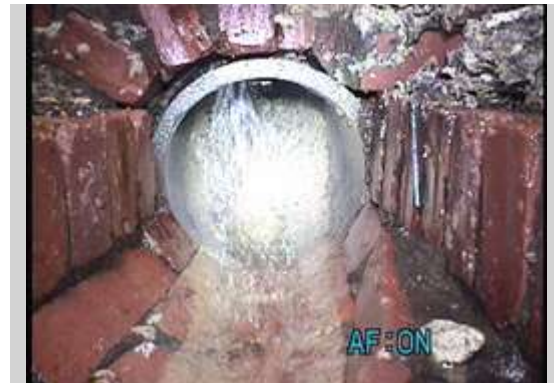
Drop In @ 6 O'Clock

Drop: **Inside** Rod and Bar
Angled: **Yes** Reading: **10.50** (ft.)
Inv Depth: **11.50** (ft.)

Drop Condition: **Open**

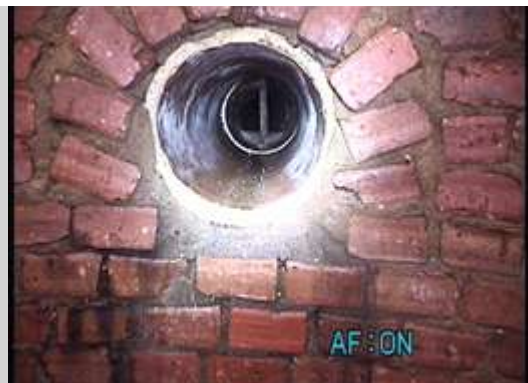
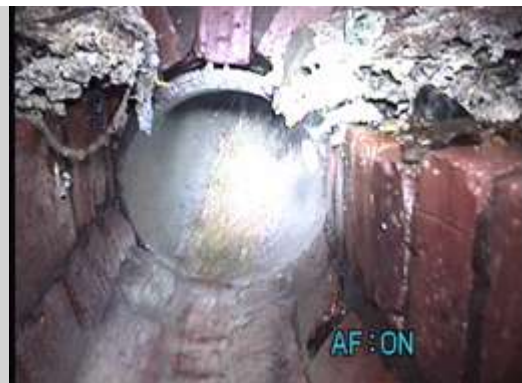
8 O'Clock Inflow

8 in. Circular Gravity Sewer
Pipe In @ 8 O'Clock

Pipe Height: **8.4** (in.) Rod and Bar (Angled)
Pipe Material: **Clay** ☐ Pipe Lined
Invert Depth: **8.35** (ft.) Flow Characteristics: **Fast**
Deposits: ☒ None ☐ Mud ☐ Sludge ☐ Debris ☐ Grease
Silt Depth: (in.) Deposits Extent:
Infiltration: **None** Pipe Seal Cond: **Sound**
